# KARĀPIRO HYDRO STATION REFURBISHMENT PROJECT

## Water intake gates.

## Generation unit replacement.

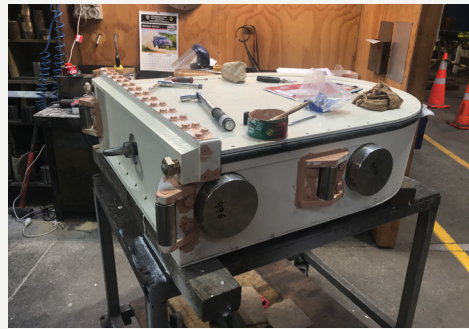
The priming valve of the gate being assembled in the AEC workshop.

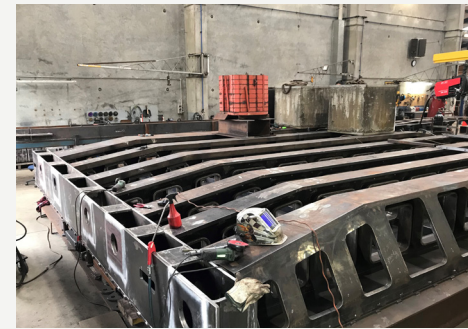
Fabrication of gate carcass at the AEC workshop.

- The girder, wheel boxes and skin plates were constructed to support the load, weight distribution, and stability of the gate.
- Key components like the wheels, sealing surfaces, and embedded frame components were fabricated and machined to very close tolerances.

- A 50-tonne crane was used to manoeuvre the gate components for manufacturing and for machining. AEC designed a custom milling machine to work on the gates.

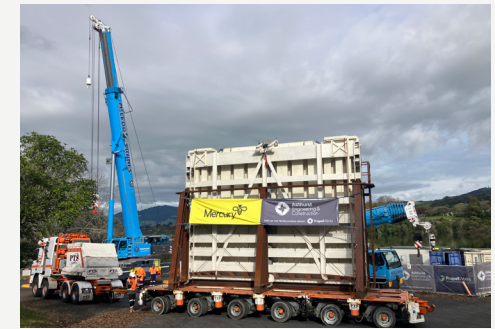
The gate is lifted into a cradle on a trailer and then reversed onto the hydro dam.

- It took about two hours for each gate to be lifted into place on the hydro dam, using three cranes and a special cradle designed by AEC.
- Once installed, the gate was tested and then commissioned for operation.

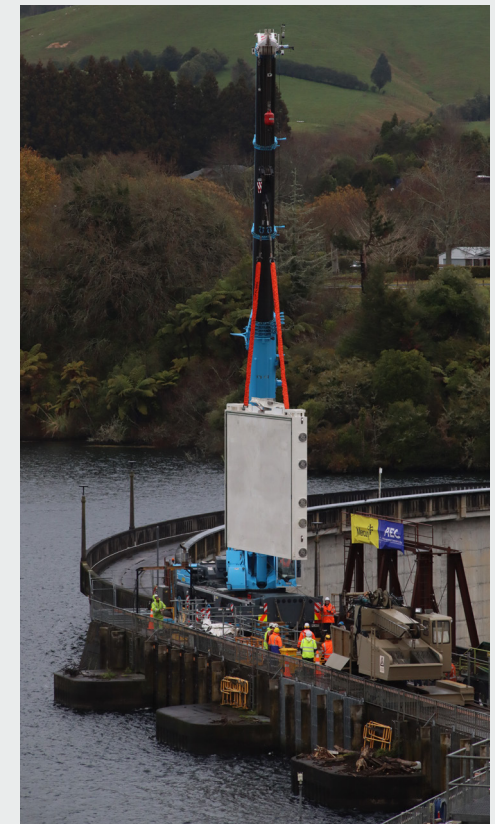
The gate being lowered into the hydro dam.

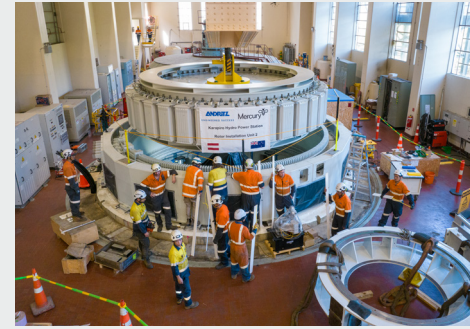
The crane delivering the rotor for Generator Two to its new stator windings.

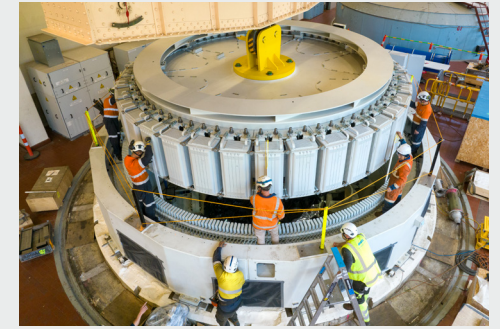
Precision work to install the rotor for Generator Two.

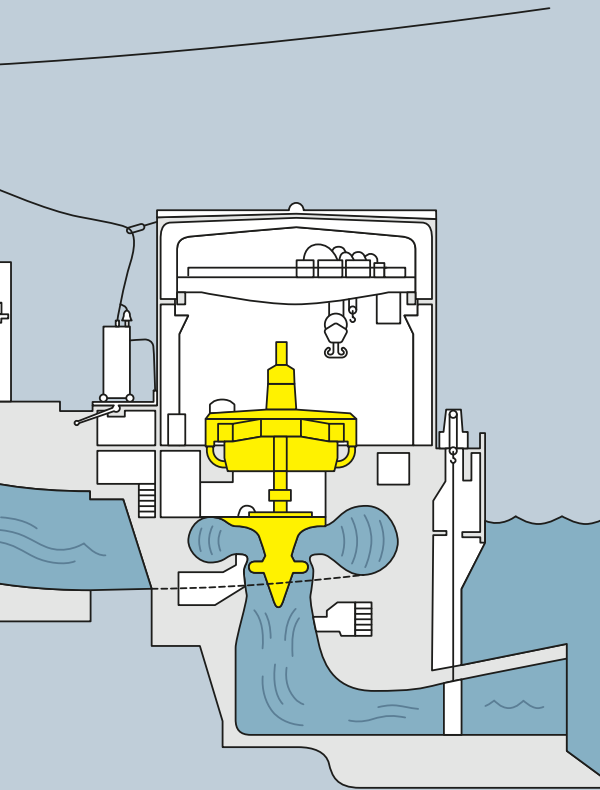
One of the original turbines removed from its chamber after decades of service.

The final of the three new turbines ready for install inside the powerhouse in April 2025.

Lowering the turbine into the chamber.

- The three 1940s-installed turbines were removed, and replaced with their modern equivalents, one each year from 2023 to 2025.
- Specialised equipment and methods were designed to surgically remove the old turbines and the chambers they were housed in. It was the first time this type of work was completed in New Zealand.
- The old turbines were recycled for scrap metal.
- New chambers were installed to house the new turbines.
- Each turbine and rotor unit were assembled on site at the powerhouse and took just under a year to install and commission.
- Working on one unit at a time meant we were able to keep generating electricity from the station during the rehabilitation project.
- Each turbine was tested during the commissioning process before entering service.
- The turbines will be removed for a service after 25 years. In total, the turbines are expected to operate for 50 years.
